Monthly Oversight Report 64  
44728 AES [46526 RAC]  
ACS NPL Site  
Griffith, Indiana  
April 1, 2006 – May 5, 2006

Subject: Monthly Oversight Summary Report  
No. 64 for April 2006

**Monthly Oversight Summary Report No. 64**  
**ACS Superfund Site**  
**TO 057, 44728.238 (AES) [WA57, 46526.238 (RAC)]**

**Reporting Period:** Month of April (April 1 through May 5, 2006)

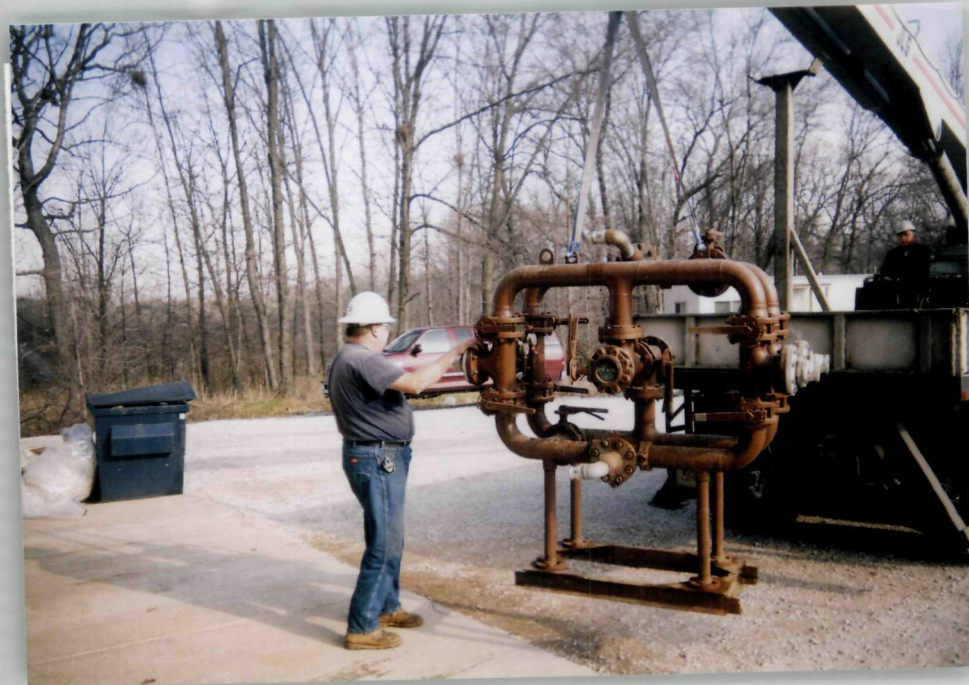
Site: American Chemical Service, Inc.  
Proj. #: 44728 AES [46526 RAC]  
Roll: 85 Photo #18  
Date: 4-12-06 Time: 0837  
Photographer: Larry Campbell  
Description: Photo facing northwest showing valving arrangement to backwash GAC tanks, after it was removed from GWTP.

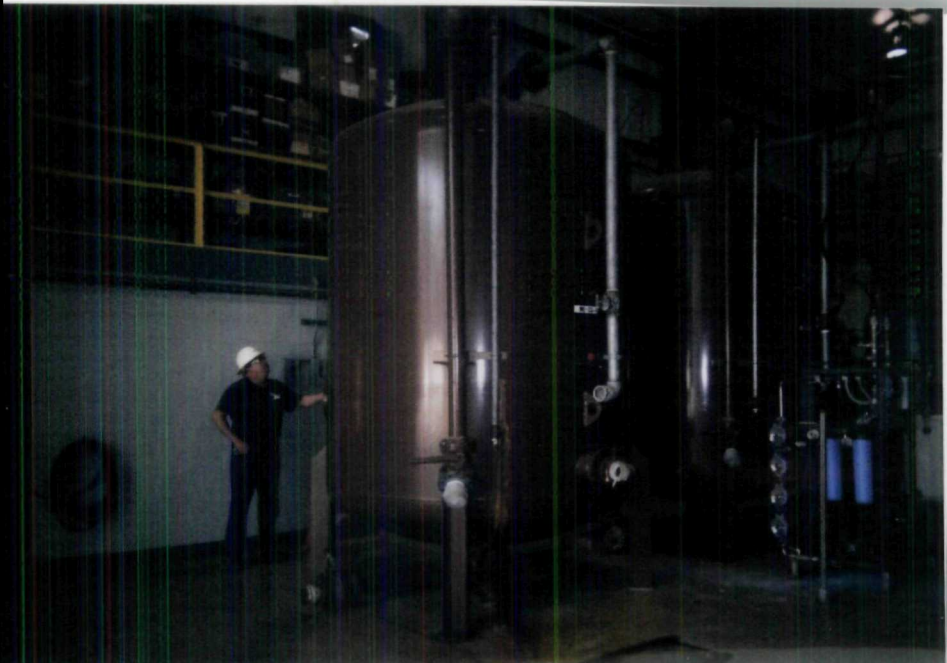
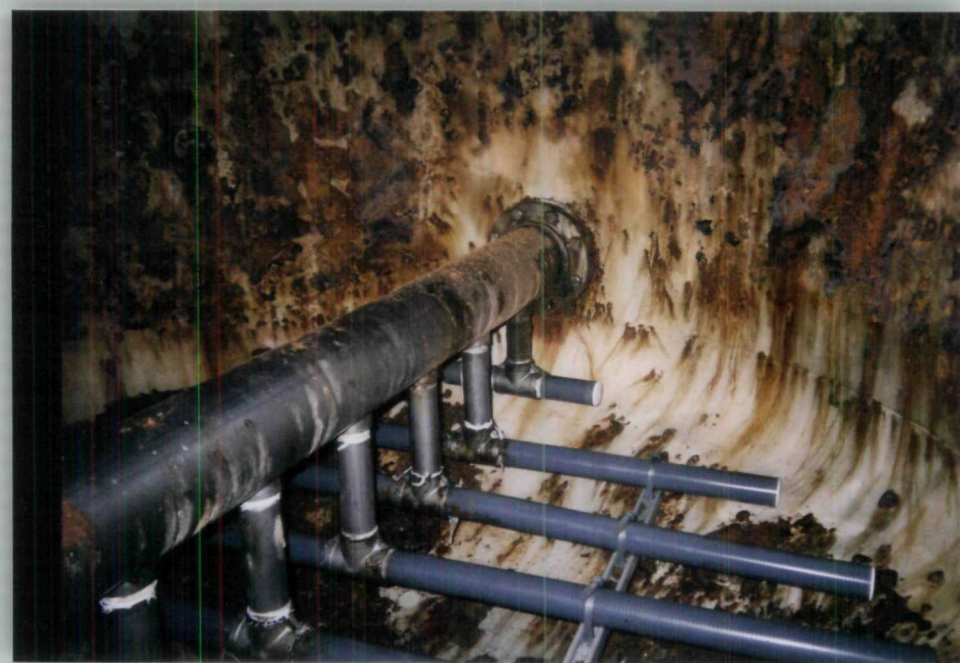
Site: American Chemical Service, Inc.  
 Proj. #: 44728 AES [46526 RAC]  
 Roll: 85 Photo #19  
 Date: 4-12-06 Time: 0840  
 Photographer: Larry Campbell  
 Description: Photo facing southeast showing GAC  
 tanks to be removed (and prior location  
 of valving unit).

Site: American Chemical Service, Inc.  
 Proj. #: 44728 AES [46526 RAC]  
 Roll: 85 Photo #20  
 Date: 4-12-06 Time: 0842  
 Photographer: Larry Campbell  
 Description: Photo facing into GAC tank ME33 after  
 all GAC had been removed.

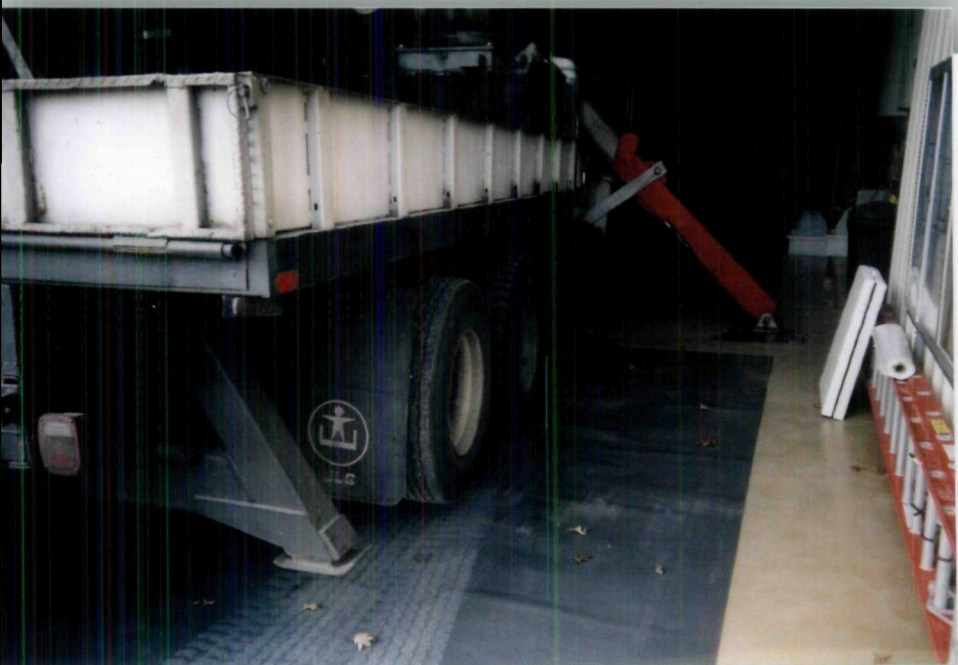
Site: American Chemical Service, Inc.  
 Proj. #: 44728 AES [46526 RAC]  
 Roll: 85 Photo #23  
 Date: 4-12-06 Time: 0850  
 Photographer: Larry Campbell  
 Description: Photo facing southeast at rear truck tires  
 on crane, showing front outrigger in  
 place.

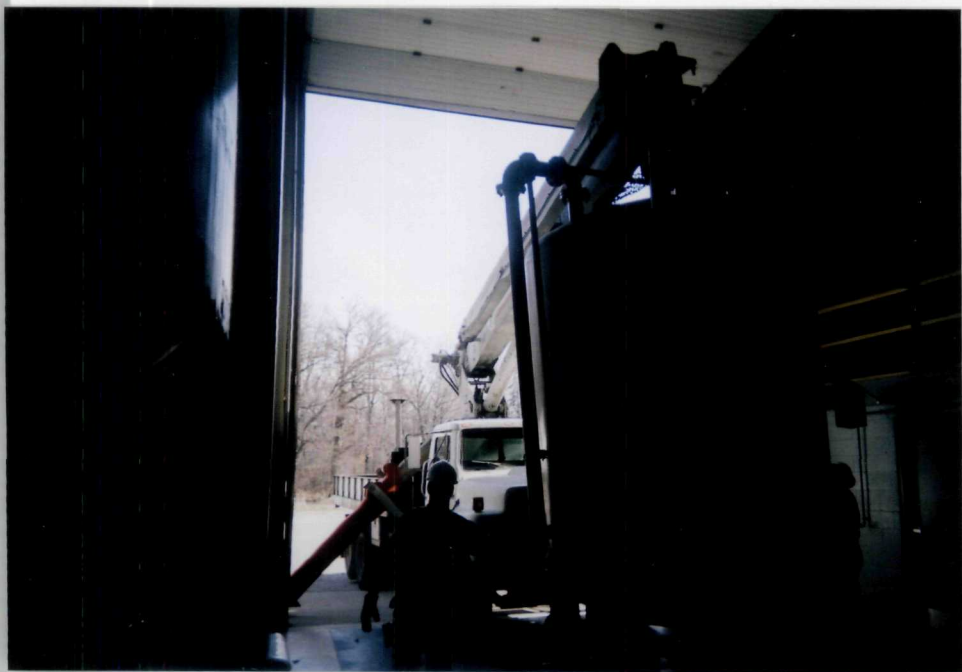
Site: American Chemical Service, Inc.  
Proj. #: 44728 AES [46526 RAC]  
Roll: 85 Photo #25  
Date: 4-12-06 Time: 0923  
Photographer: Larry Campbell  
Description: Photo facing north showing crane  
backing out of GWTP with ME33.

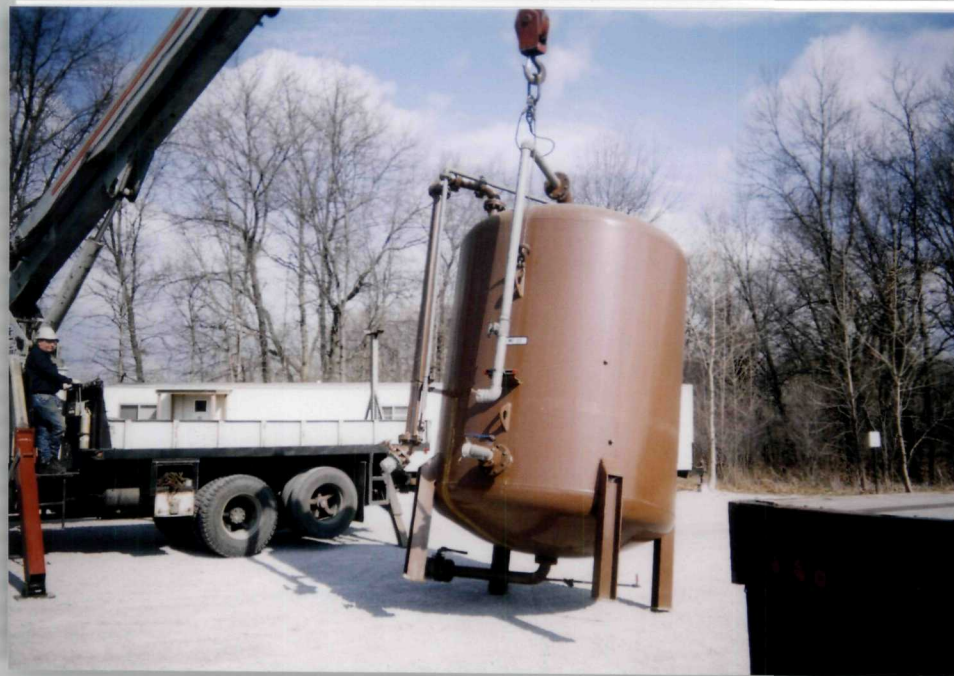
Site: American Chemical Service, Inc.  
Proj. #: 44728 AES [46526 RAC]  
Roll: 85 Photo #26  
Date: 4-12-06 Time: 0925  
Photographer: Larry Campbell  
Description: Photo facing northwest showing tank  
ME33 being tipped onto its side.

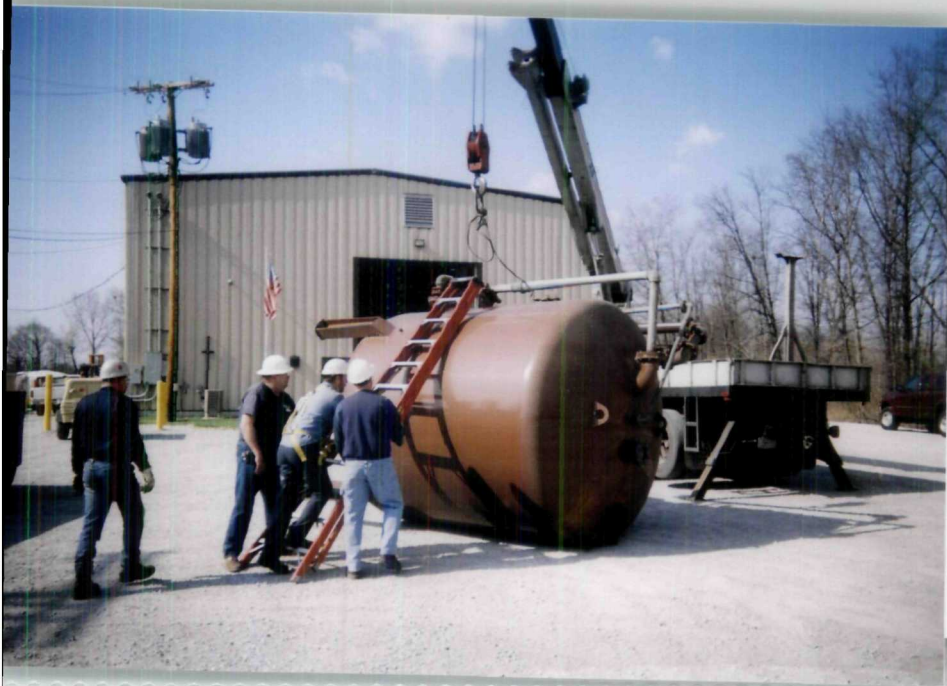
Site: American Chemical Service, Inc.  
 Proj. #: 44728 AES [46526 RAC]  
 Roll: 85 Photo #27  
 Date: 4-12-06 Time: 0930  
 Photographer: Larry Campbell  
 Description: Photo facing southwest showing ME33  
 located on its side.

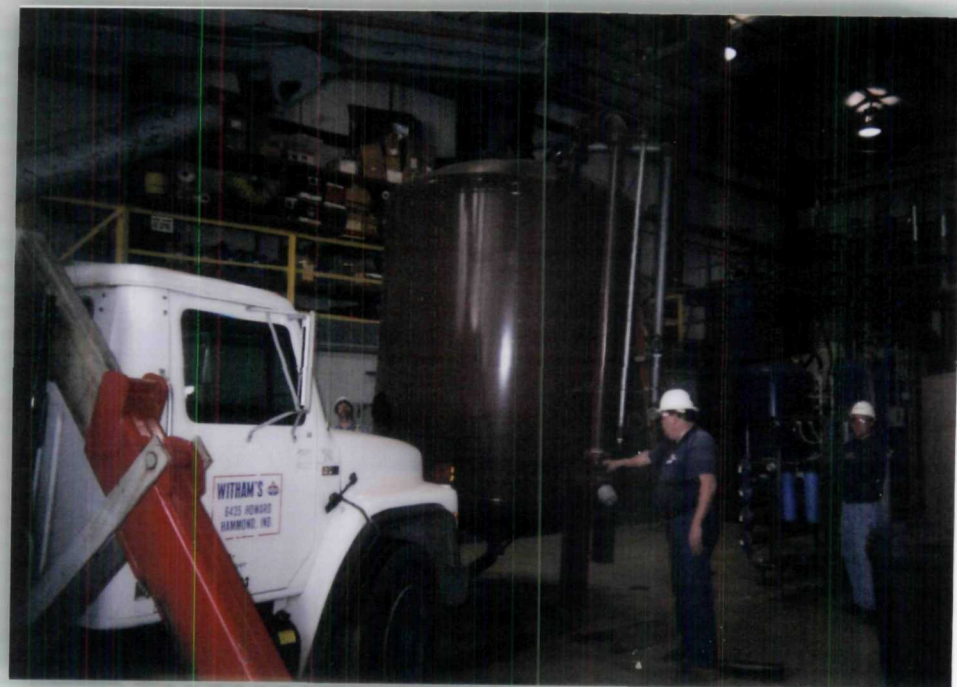
Site: American Chemical Service, Inc.  
 Proj. #: 44728 AES [46526 RAC]  
 Roll: 86 Photo #1  
 Date: 4-12-06 Time: 1013  
 Photographer: Larry Campbell  
 Description: Photo facing southeast showing ME34  
 being moved out of its prior location.  
 Note the short hookup because of  
 overhead heater.

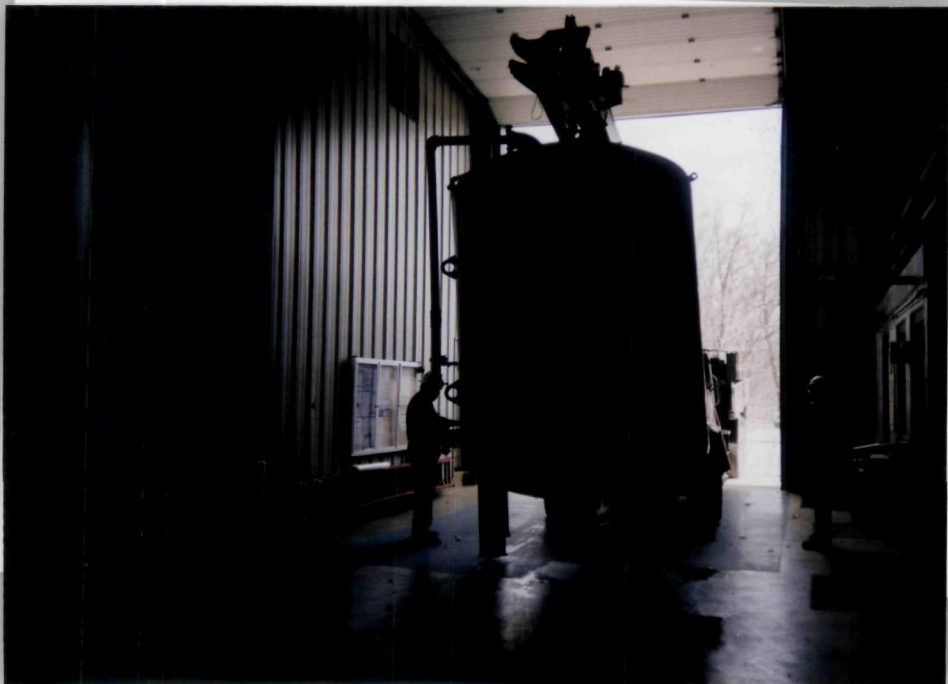
Site: American Chemical Service, Inc.  
Proj. #: 44728 AES [46526 RAC]  
Roll: 86 Photo #2  
Date: 4-12-06 Time: 1015  
Photographer: Larry Campbell  
Description: Photo facing north showing tank ME34  
being moved out of GWTP.

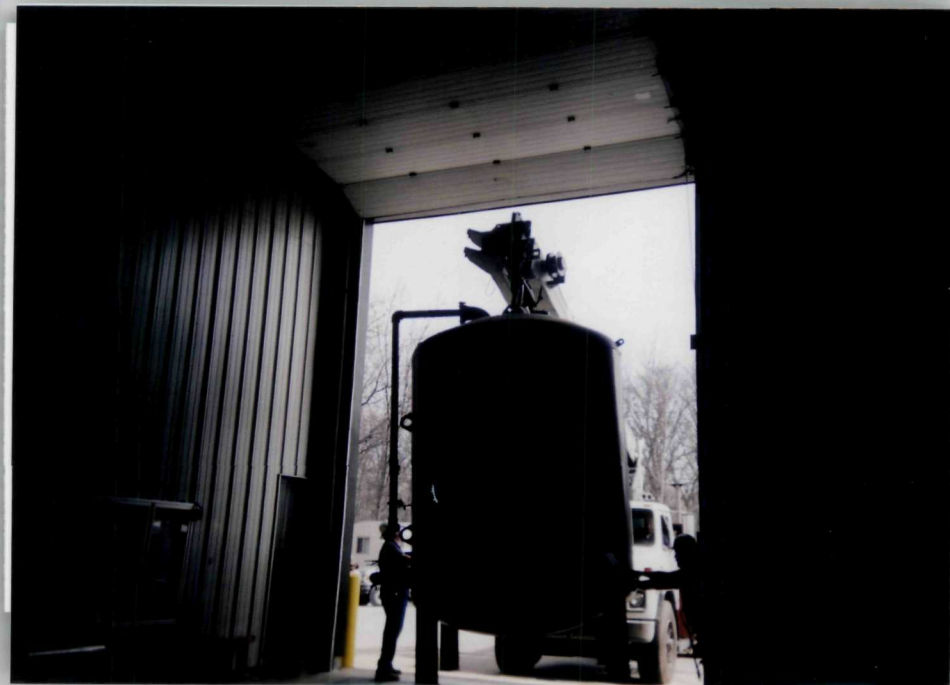
Site: American Chemical Service, Inc.  
Proj. #: 44728 AES [46526 RAC]  
Roll: 86 Photo #3  
Date: 4-12-06 Time: 1016  
Photographer: Larry Campbell  
Description: Photo facing north showing minimal  
boom clearance as ME34 is moved  
outside of GWTP.

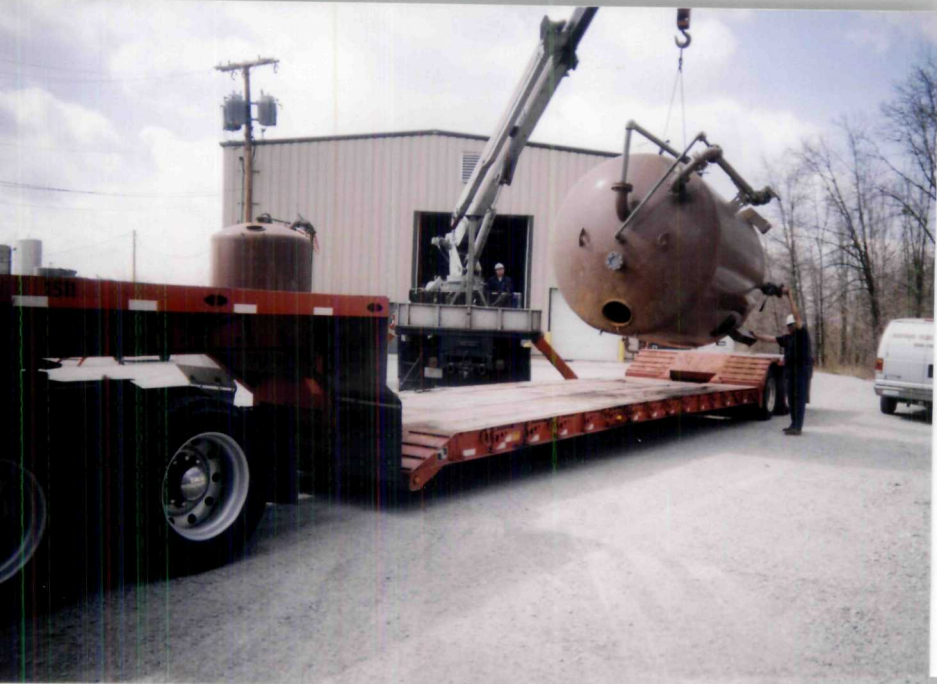
Site: American Chemical Service, Inc.  
 Proj. #: 44728 AES [46526 RAC]  
 Roll: 86 Photo #4  
 Date: 4-12-06 Time: 1029  
 Photographer: Larry Campbell  
 Description: Photo facing south showing ME33  
 being placed on low-boy truck.

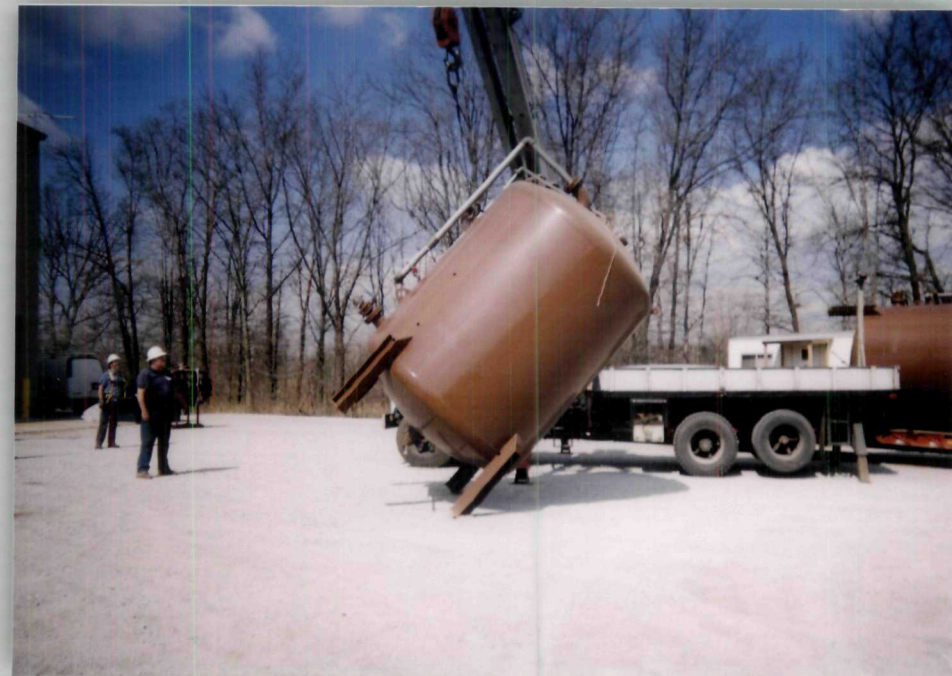
Site: American Chemical Service, Inc.  
 Proj. #: 44728 AES [46526 RAC]  
 Roll: 86 Photo #5  
 Date: 4-12-06 Time: 1044  
 Photographer: Larry Campbell  
 Description: Photo facing west showing ME34 being  
 tipped onto its side.

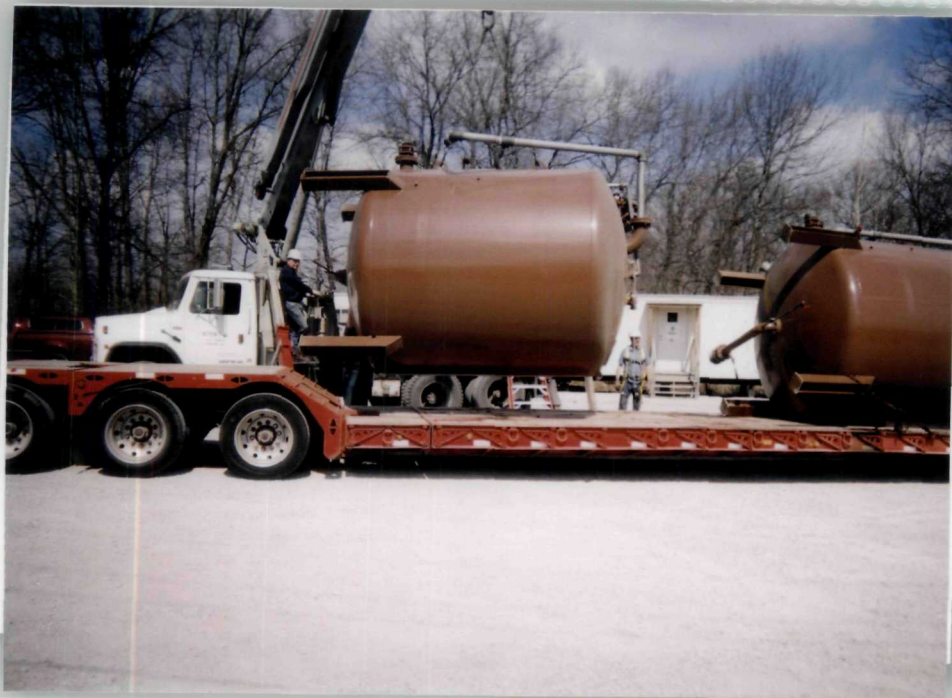
Site: American Chemical Service, Inc.  
Proj. #: 44728 AES [46526 RAC]  
Roll: 86 Photo #6  
Date: 4-12-06 Time: 1058  
Photographer: Larry Campbell  
Description: Photo facing west showing tank ME34  
being loaded onto low-boy truck.

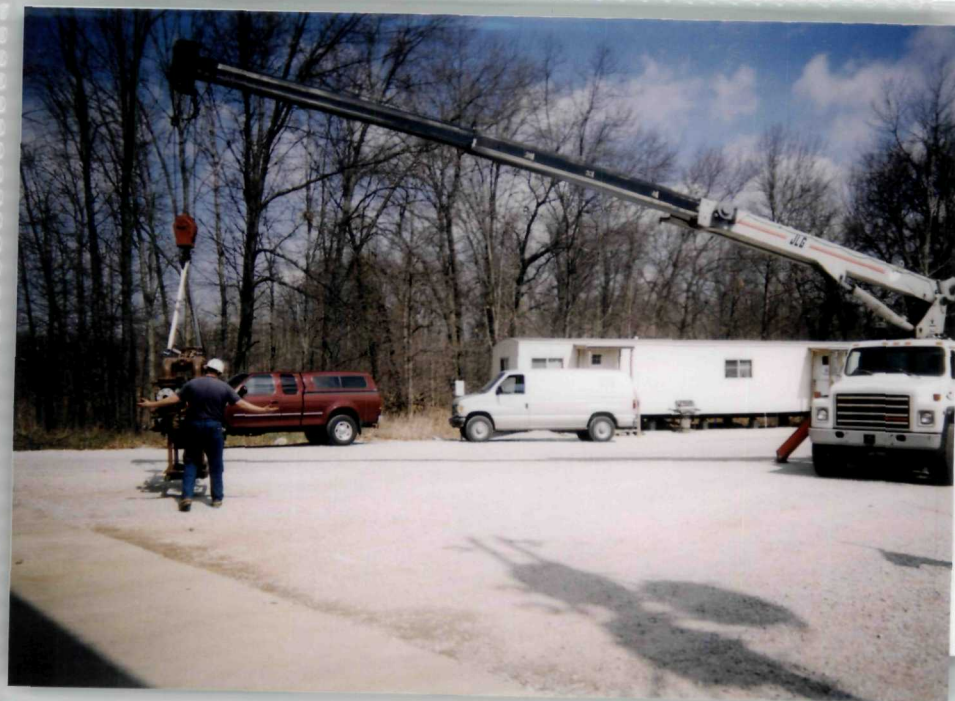
Site: American Chemical Service, Inc.  
Proj. #: 44728 AES [46526 RAC]  
Roll: 86 Photo #7  
Date: 4-12-06 Time: 1104  
Photographer: Larry Campbell  
Description: Photo facing northwest showing long-  
reach pickup of piping valve unit.

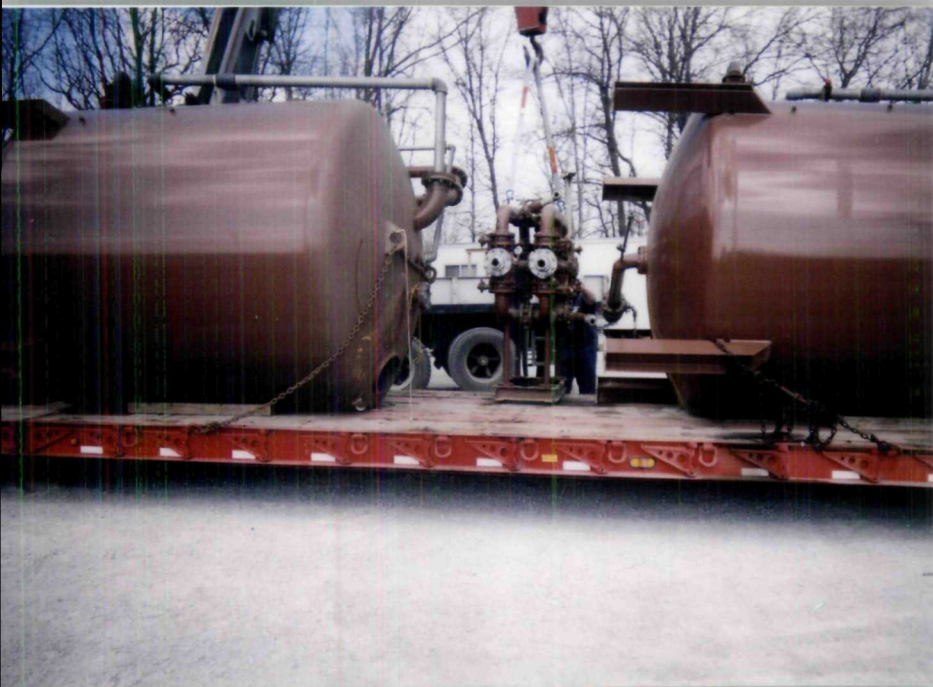
Site: American Chemical Service, Inc.  
 Proj. #: 44728 AES [46526 RAC]  
 Roll: 86 Photo #8  
 Date: 4-12-06 Time: 1106  
 Photographer: Larry Campbell  
 Description: Photo facing west showing placement  
 of piping valve unit on truck.

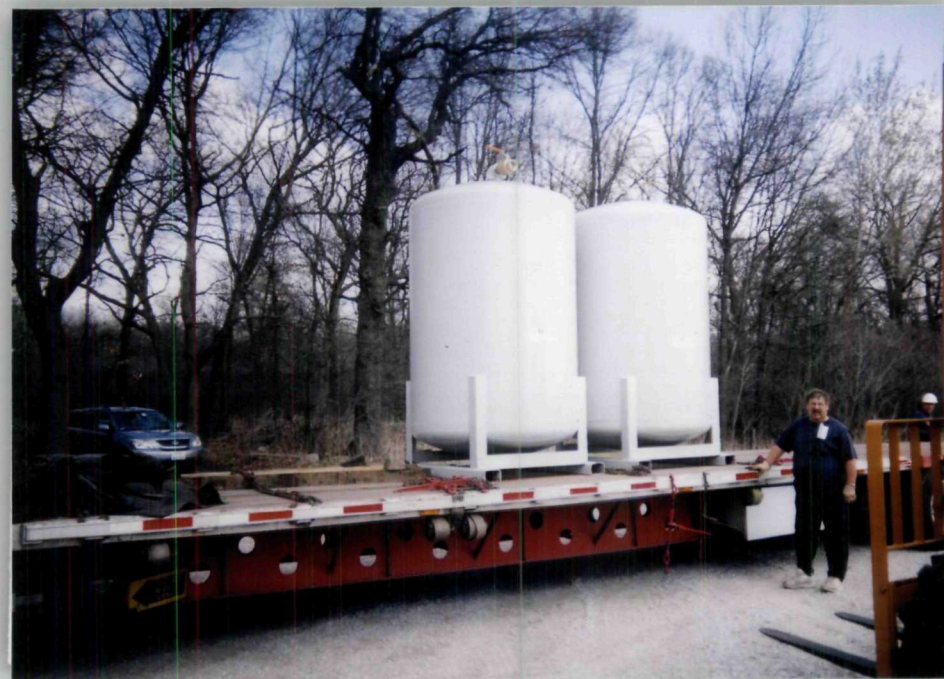
Proj. #: 44728 AES [46526 RAC]  
 Roll: 86 Photo #9  
 Date: 4-12-06 Time: 1108  
 Photographer: Larry Campbell  
 Description: Photo facing north showing new 3000  
 pound GAC tanks on delivery truck.

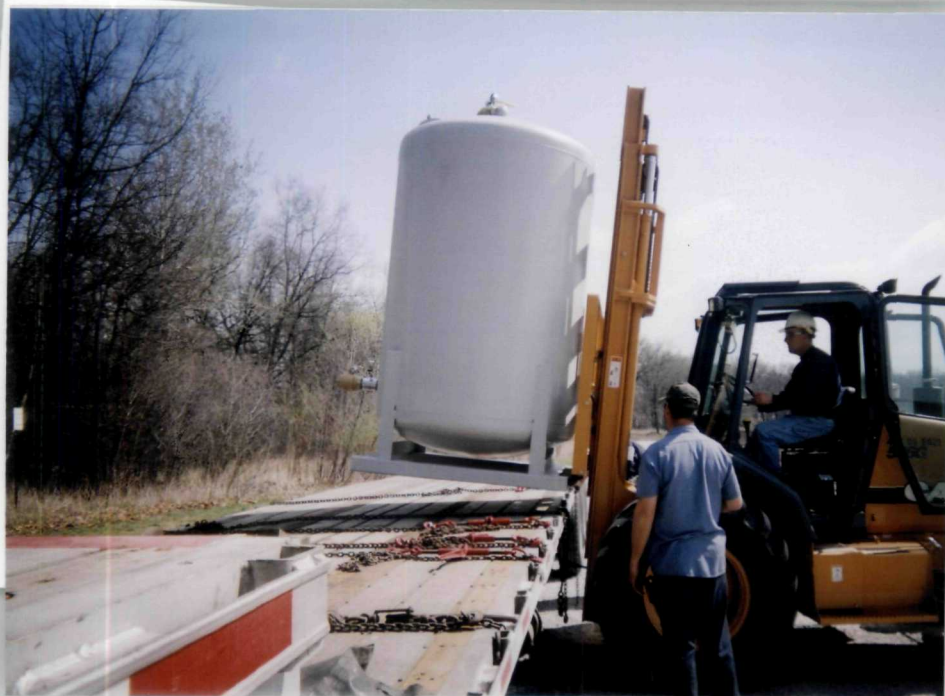
Site: American Chemical Service, Inc.  
Proj. #: 44728 AES [46526 RAC]  
Roll: 86 Photo #10  
Date: 4-12-06 Time: 1117  
Photographer: Larry Campbell  
Description: Photo facing northeast showing Lee removing GAC tank from delivery truck using fork lift.

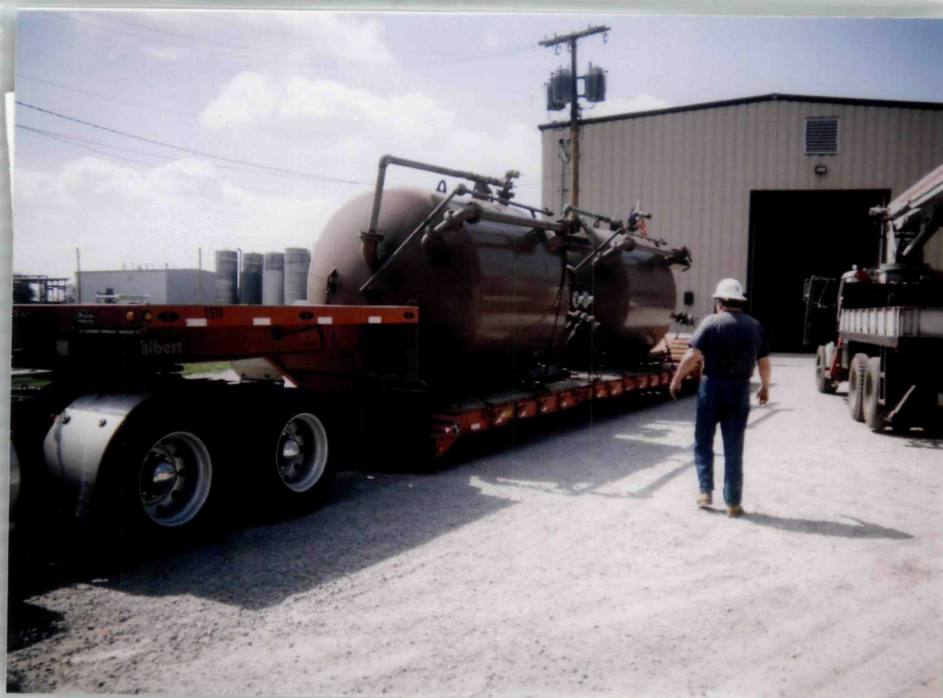
Site: American Chemical Service, Inc.  
Proj. #: 44728 AES [46526 RAC]  
Roll: 86 Photo #11  
Date: 4-12-06 Time: 1122  
Photographer: Larry Campbell  
Description: Photo facing south showing truck loaded with old GAC tanks.

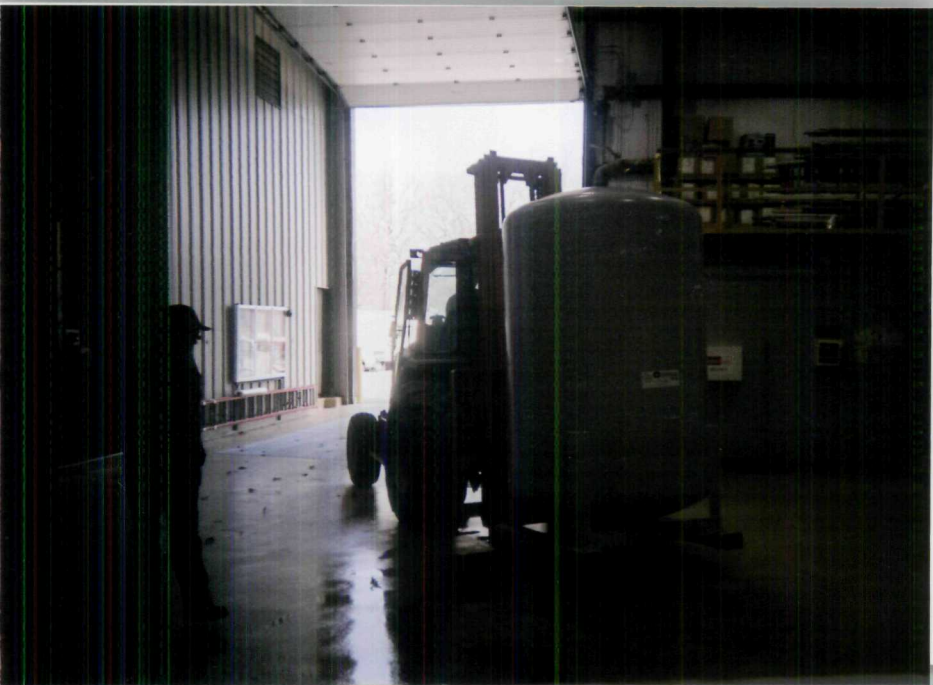
Site: American Chemical Service, Inc.  
 Proj. #: 44728 AES [46526 RAC]  
 Roll: 86 Photo #12  
 Date: 4-12-06 Time: 1124  
 Photographer: Larry Campbell  
 Description: Photo facing west showing new GAC  
 tank being moved into GWTP.

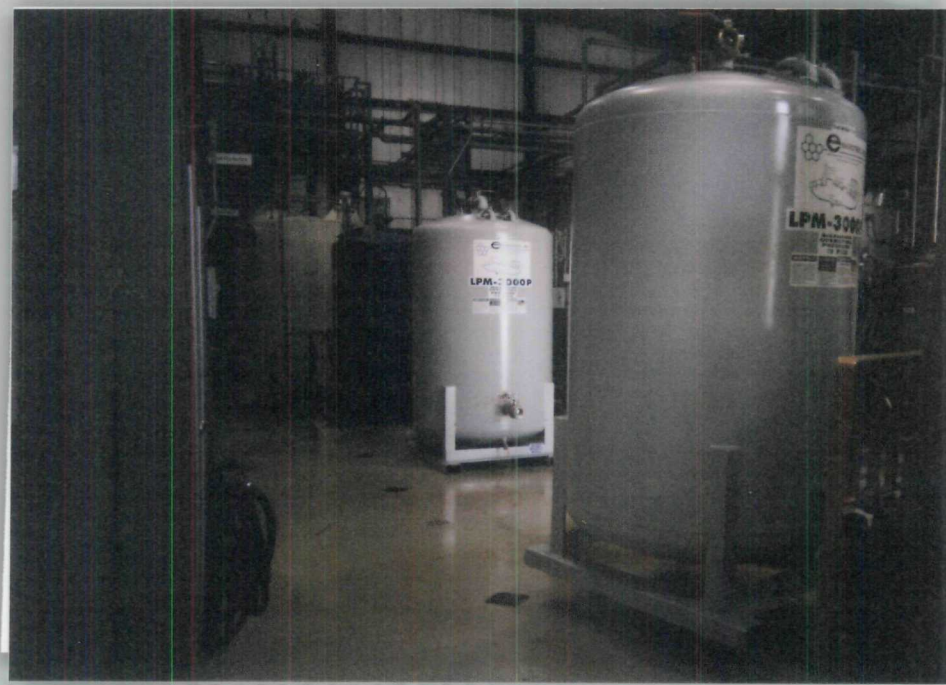
Site: American Chemical Service, Inc.  
 Proj. #: 44728 AES [46526 RAC]  
 Roll: 86 Photo #13  
 Date: 4-12-06 Time: 1127  
 Photographer: Larry Campbell  
 Description: Photo facing north showing new GAC  
 tank being moved into GWTP

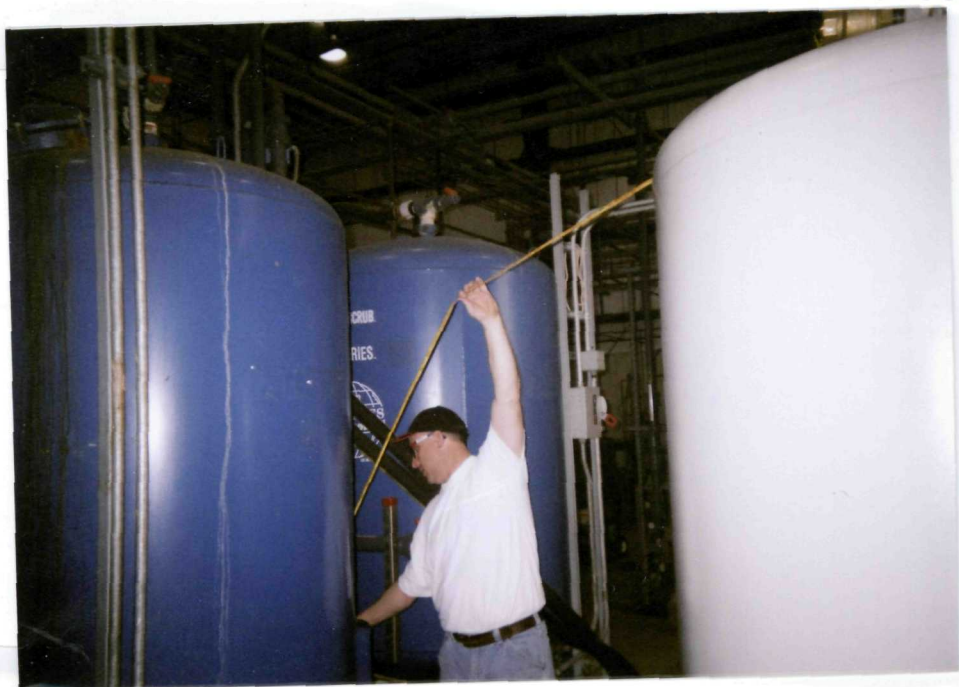
Site: American Chemical Service, Inc.  
 Proj. #: 44728 AES [46526 RAC]  
 Roll: 86 Photo #15  
 Date: 4-12-06 Time: 1244  
 Photographer: Larry Campbell  
 Description: Photo facing south showing new GAC  
 tanks in place in GWTP
